Final Reconciliation of 2010-15 period

Appendix 1

Ofwat Blind Year Reconciliation

Discoloured water contacts

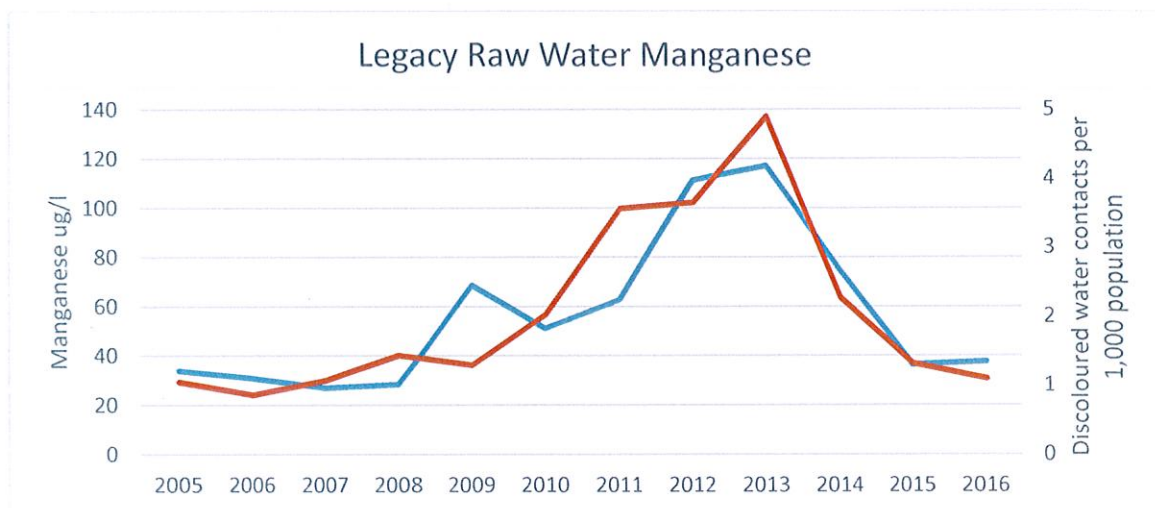
Our serviceability levels for the AMP5 period were set based on performance levels achieved prior to the determination in 2009. This period was before the raw water deterioration issue at Legacy treatment works which was a major contributor to our higher levels of contacts and the reason that we exceeded the serviceability level.

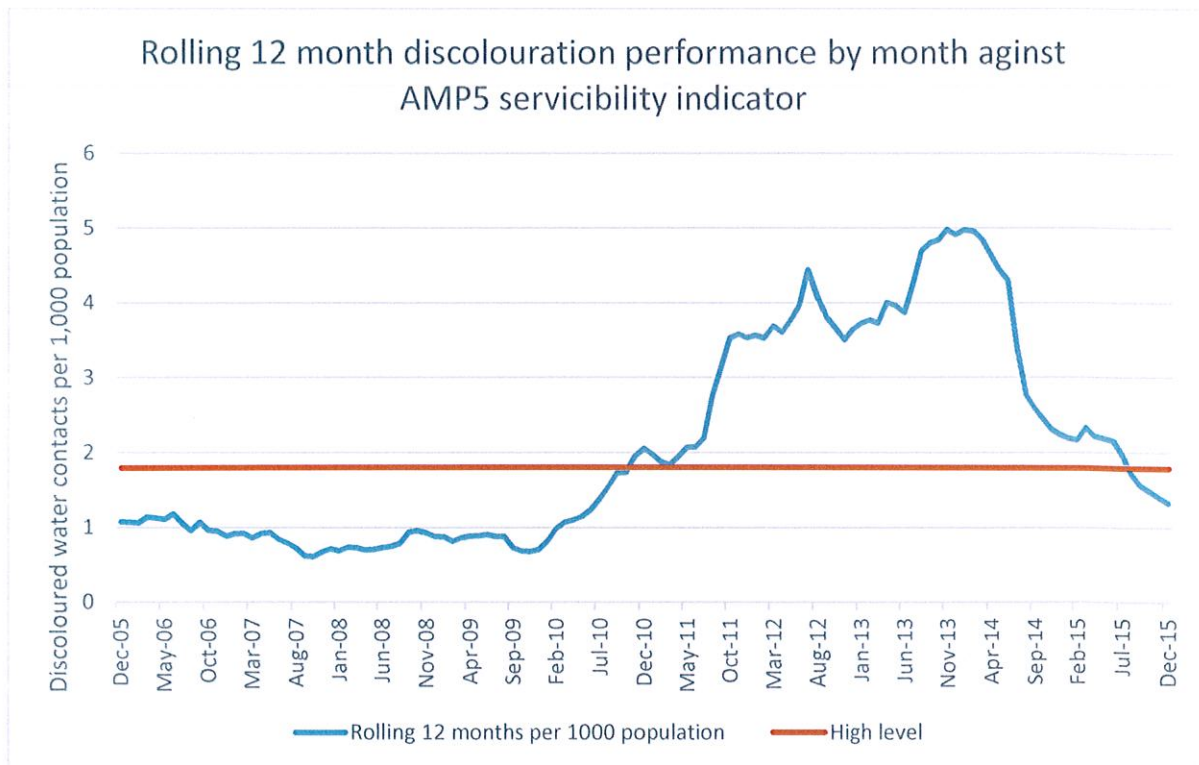
Due to the raw water deterioration after the start of the AMP period, short to medium term measures were enacted to drive down discolouration as much as practicable given the constraints listed above. These measures included greater monitoring of source water quality and a protocol for selecting low risk sources where possible as well as our largest ever mains cleaning programme. These measures were delivered without any additional cost to our customers and reduced our discolouration contact numbers from greater than c.1300 in 2013 to c.600 by 2014 and c.350 in 2015. As can be seen from the graph below these measures successfully reduced discolouration contacts to below the AMP5 serviceability high level of 1.8 by August 2015.
